## **Baseline Property Condition Assessment**

Minneapolis Fire Department (Former) Station No. 14  
1704 33<sup>rd</sup> Avenue North  
Minneapolis, Minnesota

Project No. B14-07520  
December 1, 2014

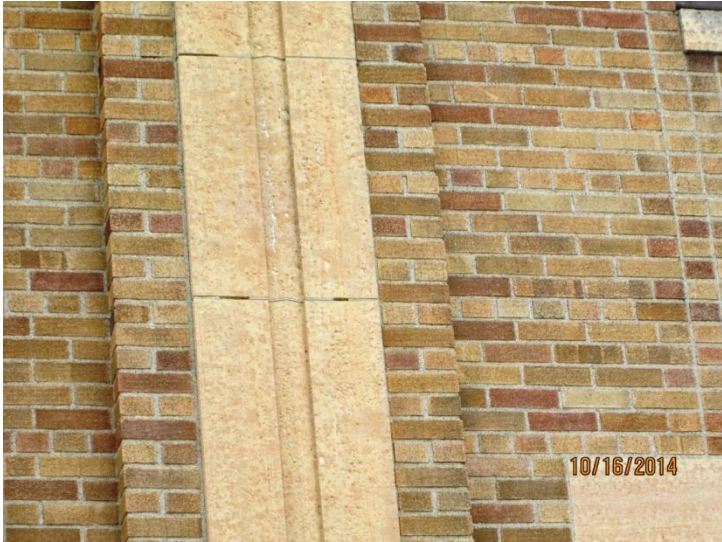
The brick masonry shows some minor evidence of some needed tuck pointing. The brick masonry tuck pointing costs are noted "Exhibit D – Ten Year Cost Reserves."

**Photograph 5**  
Tuck Pointing at Cast Stone Required

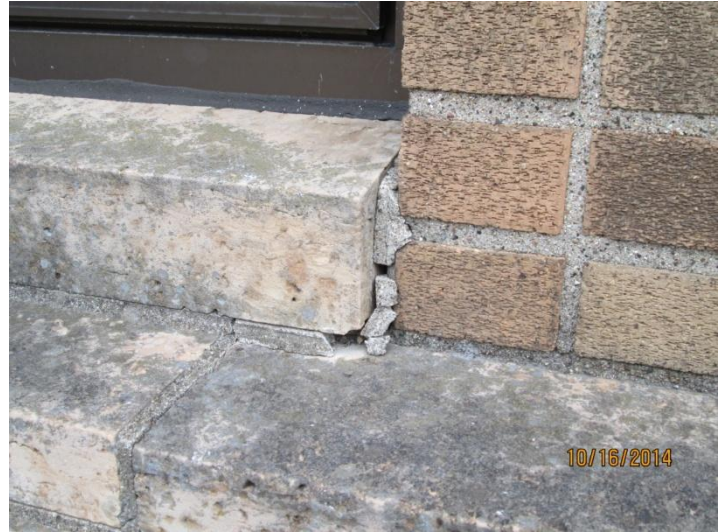
**Photograph 6**  
Tuck Pointing at Cast Stone Sill Required

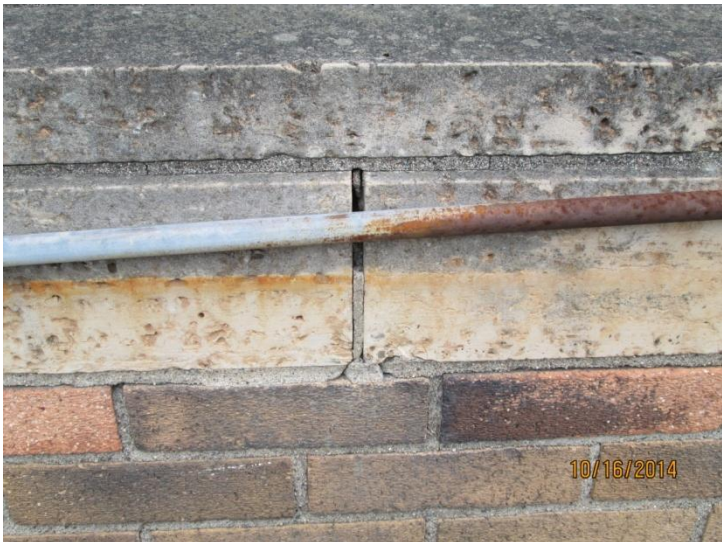
**Photograph 7**  
xTuck Pointing at Cast Stone Sill Required

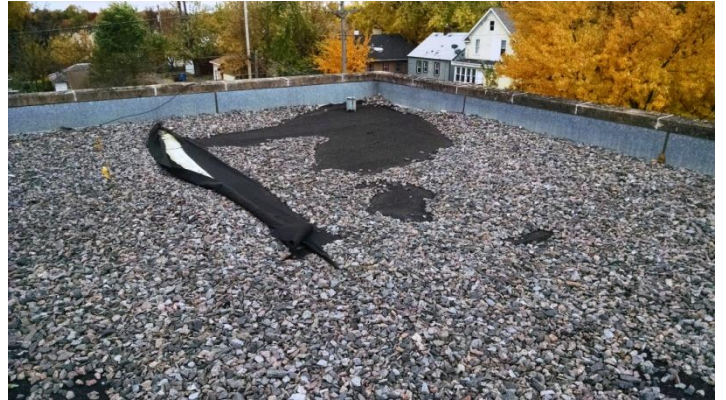
The high roof has locations of wind scouring where the rock ballast was blown off the filter fabric. The filter fabric has torn exposing the insulation below. These locations can be easily repaired. We also observed one location where the metal counter flashing has become disconnected along the eastern parapet wall. The base flashing and brick are exposed to the weather. This also can be easily repaired. We did not observe evidence of interior water damage from roof leakage.

**Photograph 10**  
Wind Scouring at Rock Ballast

Both roof systems have an estimated useful life of about 25 years. We are unaware of the age of either roof but we would recommend making repairs as described above. The costs for these roof repairs are noted in “Exhibit C – Immediate Physical Needs.”

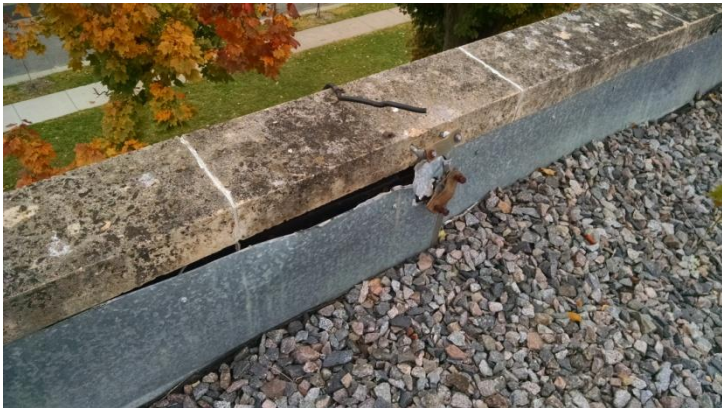
**Photograph 11**  
"Loose" Metal Counter Flashing

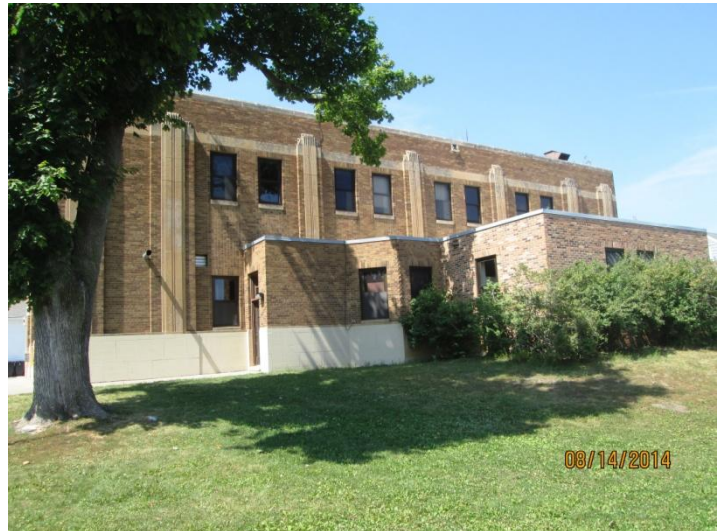
The landscaping observed appeared to be healthy and in good condition but is in need of some clean-up, maintenance and replacement. The costs for this are noted in "Exhibit D – Ten Year Cost Reserves."

**Photograph 12**  
Grass, Shrubs & Trees

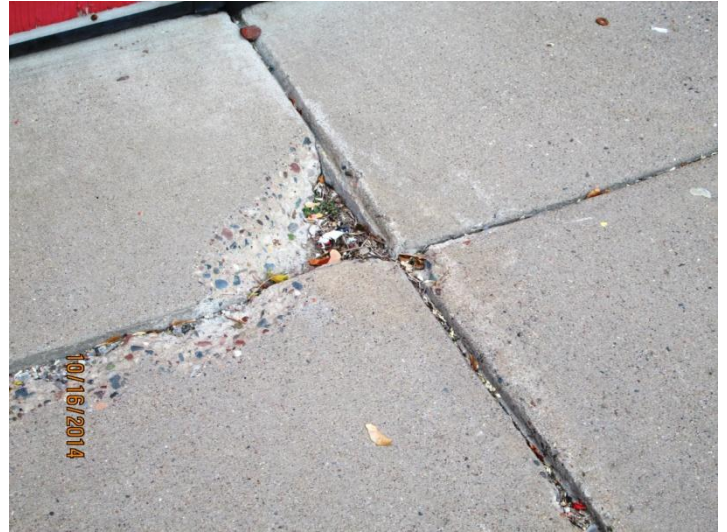
The concrete paving for the majority of the areas was observed to be in fair condition with evidence of long term "wear" and some "cracking" and "chipping." "Concrete Paving Crack Repairs" are noted in "Exhibit D – Ten Year Cost Reserves."

**Photograph 14**  
"Chipped" Concrete Paved Entry/Exit Drive

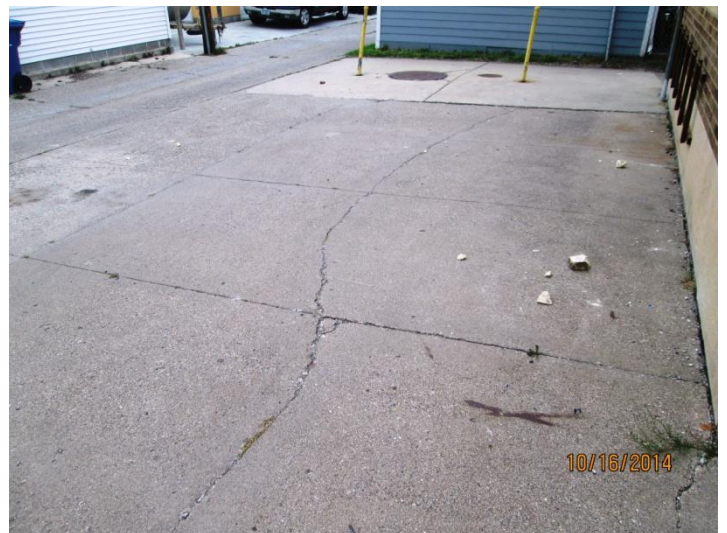
The asphalt paving for the majority of the areas was observed to be in fair condition with evidence of long term "wear" and "cracking." The "Asphalt Paving Patching & Seal Coat" are noted in "Exhibit D – Ten Year Cost Reserves."

**Photograph 16**  
"Cracks" at Asphalt Paved Area

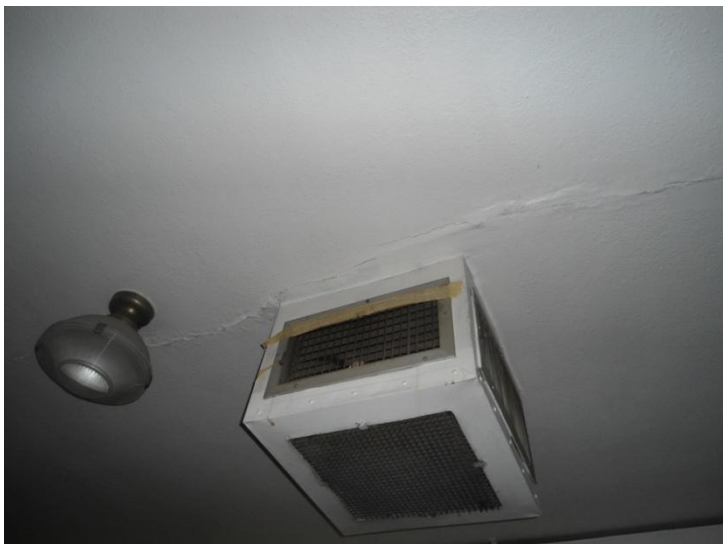
Some cracking was observed in the lath and plaster finishes covering the structural elements on the second floor but the cracking did not appear to be due to structural deficiency or distress, but more likely due to the age of the building. One long crack was observed in the lath and plaster ceiling of above the second floor dormitory area. This crack had some water staining around it and may have been a result of water intrusion prior to the replacement of the roof system. The remaining structural elements and masonry bearing walls throughout the building appeared to be in good condition for their age and would be suitable for continued use and to serve their intended purpose.

**Photograph 31**  
"Cracking" at Second Floor Lath & Plaster

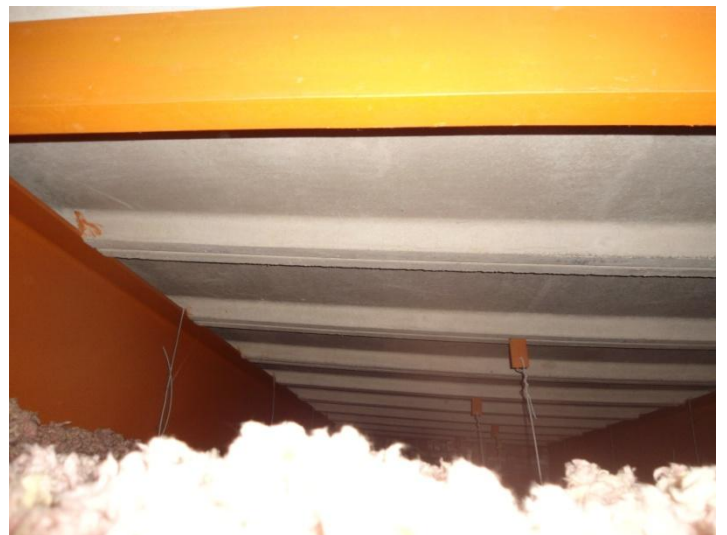
The structural support for the roof system of the main building consists of steel beams spanning between the exterior walls with pre-cast concrete plank. Based upon the observed condition of the steel beams and the presence of the pre-cast planks, it was determined that the roof system is not original to the building and must have been replaced at some point.

**Photograph 32**  
Roof Framing Above Ceiling

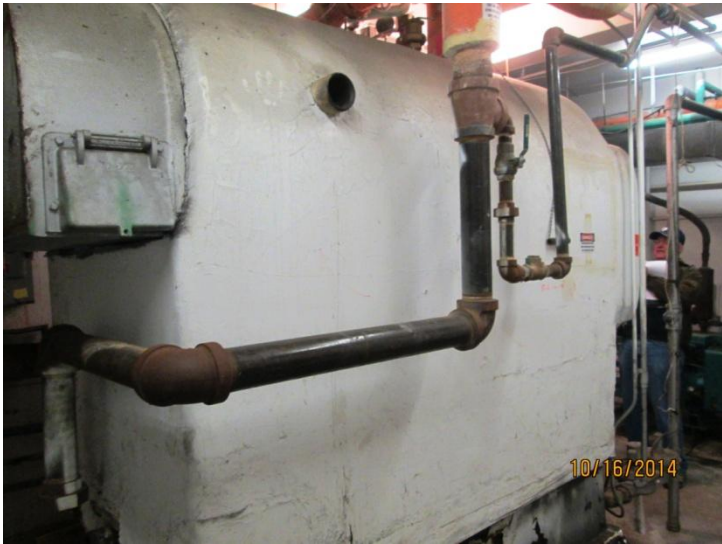
The majority of the heating system (boilers – 50 years, cast iron radiators – 50 years, burners – 20 years, oil tanks – 20 years, condensate pumps – 20 years) has exceeded its average useful life and should be replaced. The condition of the steam and condensate piping is unknown and is approaching the end of its average useful life. According to the asbestos report, the majority of the insulation for this system is asbestos. The estimated cost to replace this system is noted in “Exhibit C – Immediate Physical Needs.”

**Photograph 33**  
Steam Boiler

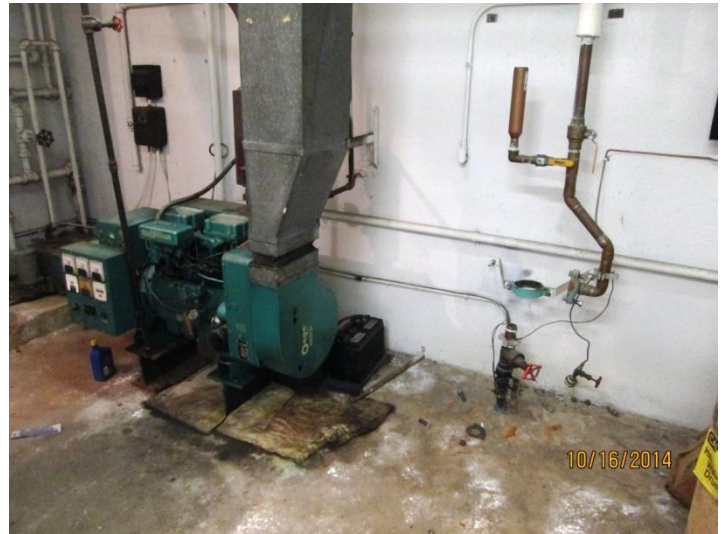
Gas service was provided by the gas pressure regulator and meter located in the northeast corner room in the basement. Gas pressure regulator should be vented outside. An underground fuel oil tank (size unknown) appears to be located in the northwest corner of the Site. Its age and condition are unknown. Combustion air is provided for the fuel fired devices. The boiler breeching has a barometric damper. The breeching connects to a brick chimney extending through the roof.

**Photograph 34**  
Gas Pressure Regulator

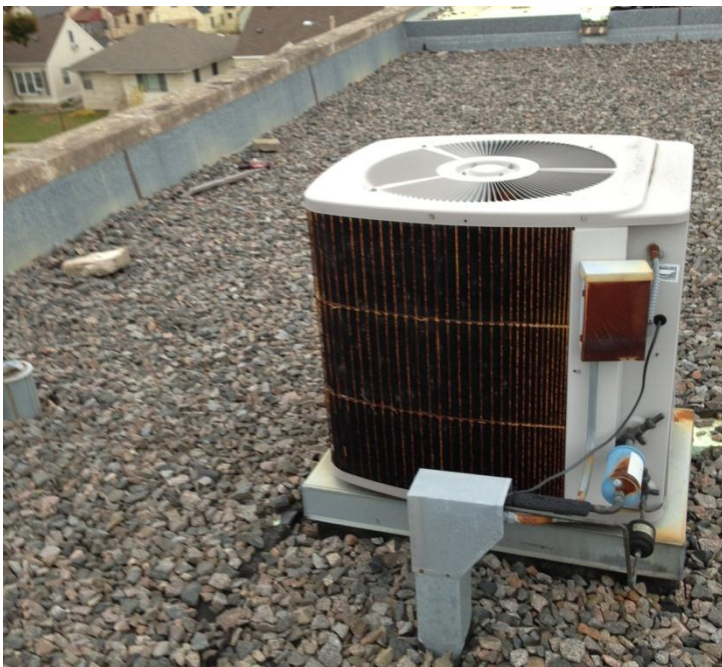
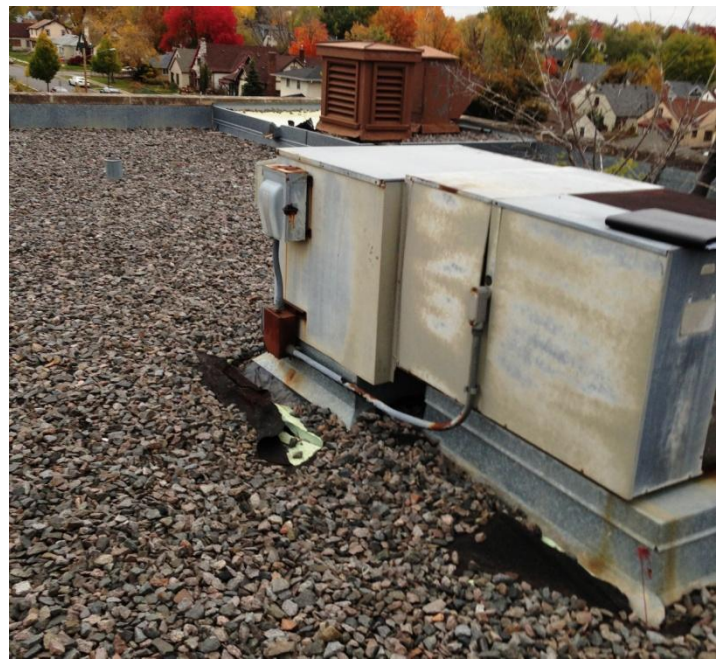
The air conditioning for this building was provided with two cooling-only roof top units and one fan coil with condensing unit on the roof. One roof top unit served the dormitory portion of the upper level. This unit was blown off during a tornado a few years ago and has not been replaced. One roof top unit served the remainder of the second floor (training room, offices, and toilets). Both of the roof top units were added sometime after the building was built and have exposed duct work. The fan coil is located in the first floor ceiling space and provides cooling to the dining room, kitchen, and toilet. The condensing unit is mounted on the roof. The addition is cooled with a through-the-wall air conditioner. All of this equipment appears to have exceeded their average useful life (20 years) and should be replaced. The estimated cost to replace the air conditioning system is noted in “Exhibit C – Immediate Physical Needs.”

**Photograph 35**  
Roof-Top Air Conditioning

**Photograph 36**  
Roof-Top Air Conditioning
